## Identifying Potential Earthquake Dangers To Alaska's Students and Schools

A Pilot Project Screening Matanuska-Susitna School District Buildings  
February 6, 2015

Study Conducted by: BBFM Engineers, Inc.  
Sponsored by:

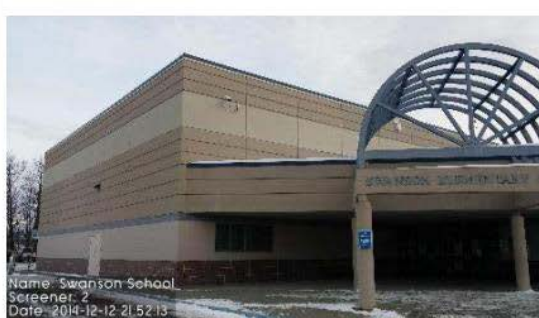
| | Address: 609 N Gulkana St<br>Zip: 99645<br>Other Identifiers:<br>No. Stories: 2<br>Year Built: 1955<br>Screener: 2<br>Date: None<br>Total Floor Area (sq. ft.): 50135<br>Building Name: <b>Swanson 1950's, 1958, 1963</b><br>Use: None |

- 7) Swanson Elementary School: 1950's Original Construction
  - Lateral system appears to be concrete floors supported by plywood shear walls
  - Original construction was single story; later a second floor was added

- Final score = 1.4; FEMA estimate of collapse risk: 4%
  - Additional review is required
- 8) Swanson Elementary School: 1958 Addition
  - Lateral system appears to be concrete floors supported by plywood shear walls

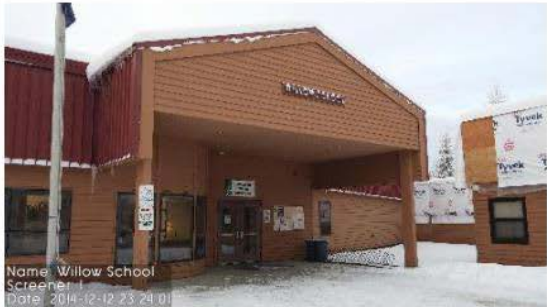
| | Address: 31706 Parks Highway<br>Zip: 99688<br>Other Identifiers:<br>No Stories: 2<br>Year Built: 1976<br>Screener: 1<br>Date: None<br>Total Floor Area (sq. ft.): 34757<br>Building Name: <b>Willow 1976</b><br>Use: None |

- 12) Willow Elementary School: 1976 Addition
  - Masonry construction
  - Final score = 2.3; FEMA estimate of collapse risk: 0.5%
  - No additional review is indicated

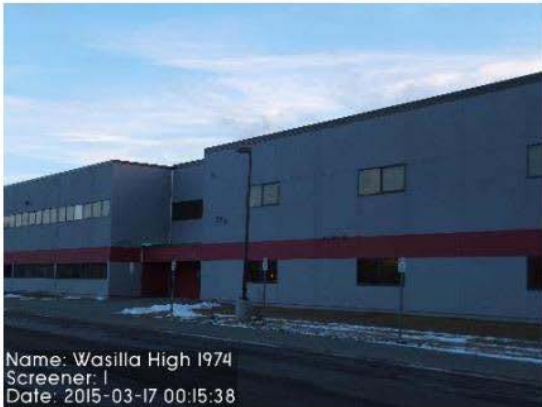
| No Sketch | Address: 701 E Bogard Rd<br>Zip: 99654<br>Other Identifiers:<br>No Stories: 2<br>Year Built: 1974<br>Screener: 1<br>Date: None<br>Total Floor Area (sq. ft.): 212206<br>Building Name: <b>Wasilla High 1974</b><br>Use: None |

- 14) Wasilla High School: 1974 Original Construction
  - Masonry and concrete shear walls construction

- Final score = 1.6; FEMA estimate of collapse risk: 3%  
Additional review is required

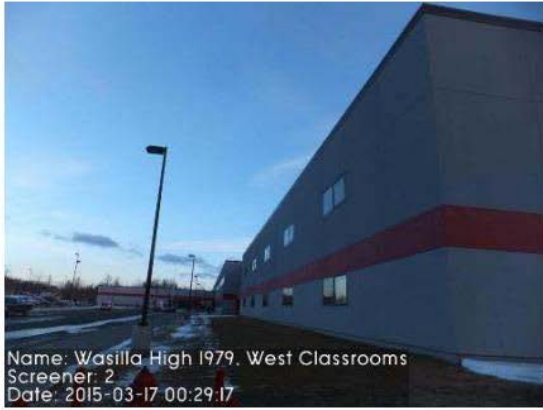
| No Sketch | Address: 701 E Bogard Rd<br>Zip: 99654<br>Other Identifiers:<br>No Stories: 2<br>Year Built: 1979<br>Screener: 2<br>Date: None<br>Total Floor Area (sq. ft.): 212206<br>Building Name: <b>Wasilla High 1979, West Classrooms</b><br>Use: None |

- 15) Wasilla High School: 1979, West Classroom Addition
- Steel braced frame and steel moment frame construction
  - Final score = 1.9; FEMA estimate of collapse risk: 1.3%
  - Additional review is required

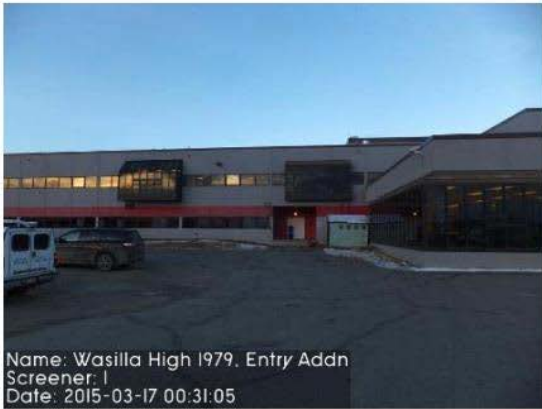
- 16) Wasilla High School: 1979, Entry Addition
- Steel frame tied to existing building construction
  - Final score = 1.6; FEMA estimate of collapse risk: 3%
  - Additional review is required

| Occupancy | | | | Soil Type | | | | Falling Hazard | | | | |
|---|---|---|---|---|---|---|---|---|---|---|---|---|
| <input type="checkbox"/> Commercial | <input type="checkbox"/> Historic | <input type="checkbox"/> Residential | <input type="checkbox"/> 0-10 <input type="checkbox"/> 11-100 | <input type="checkbox"/> | <input type="checkbox"/> | <input checked="" type="checkbox"/> | <input type="checkbox"/> | <input type="checkbox"/> | <input type="checkbox"/> | Other:<br>Inadequately tied to 1974 str | | |

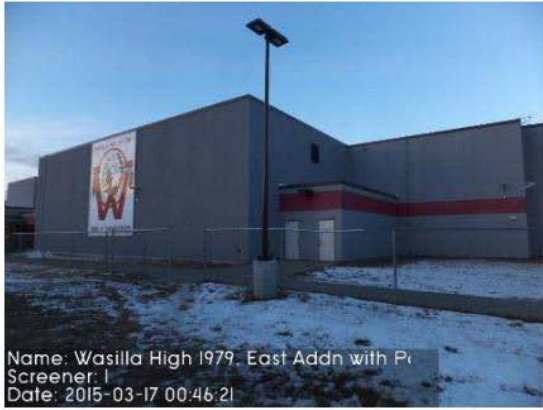
- 17) Wasilla High School: 1979, East Addition With Pool
- Precast and masonry construction
  - Final score = 0.3; FEMA estimate of collapse risk: 50%
  - Additional review is required
