## Identifying Potential Earthquake Dangers To Alaska's Students and Schools

A Pilot Project Screening Matanuska-Susitna School District Buildings  
February 6, 2015

Study Conducted by: BBFM Engineers, Inc.  
Sponsored by:

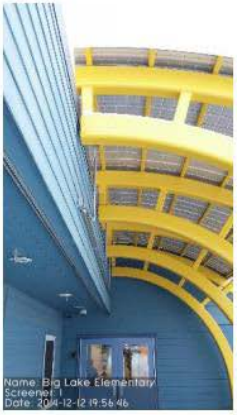
- 1) Big Lake Elementary School: 1963 Original Construction
  - Wood construction
  - Final score = 2.3; FEMA estimate of collapse risk: 0.5%
  - no additional review is indicated

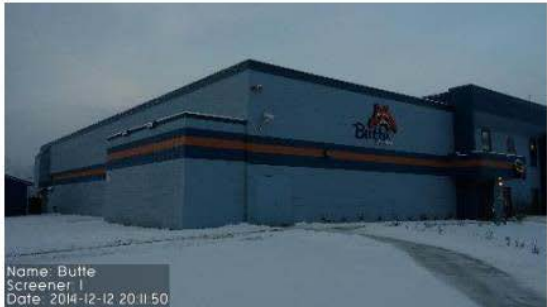
- Additional review is required for the possible pounding with the entry canopy
- 4) Butte Elementary School: 1978
  - Wood construction
  - Final score = 4.8; FEMA estimate of collapse risk: 0.002%

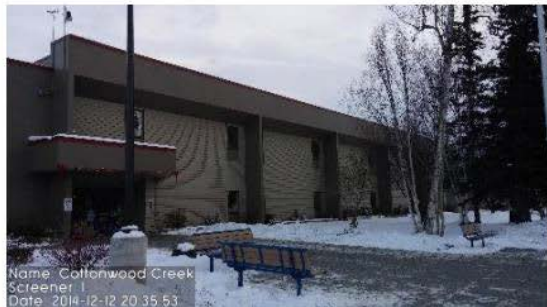
- no additional review is indicated
- 5) Cottonwood Creek Elementary School: 1981
  - Wood construction
  - Final score = 4.8; FEMA estimate of collapse risk: 0.002%

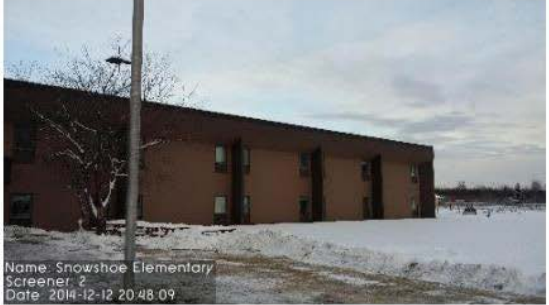
- 6) Snowshoe Elementary School: 1978
  - Wood construction
  - Final score = 4.8; FEMA estimate of collapse risk: 0.002%
  - no additional review is indicated
